"Full" Reserve Study

Ponderosa Townhome Estates No. 1 Tucson, AZ

Report #: 23283-0
For Period Beginning: July 1, 2020
Expires: June 30, 2021

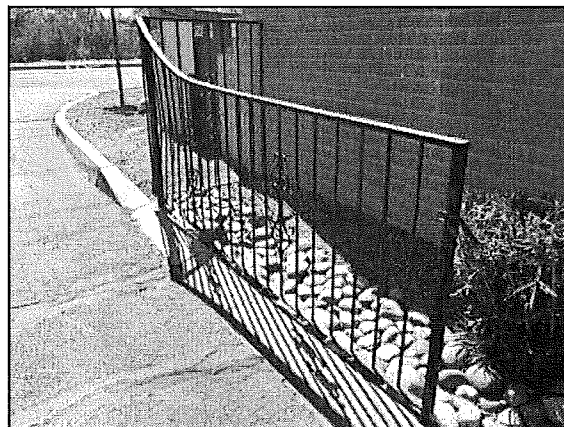
Comp #: 110 Vehicle Gates - Replace**Quantity: (2) Gates**

Comments: Appear to be intact and in fair shape. Future replacement should be anticipated. Repaint as needed with Operating funds.

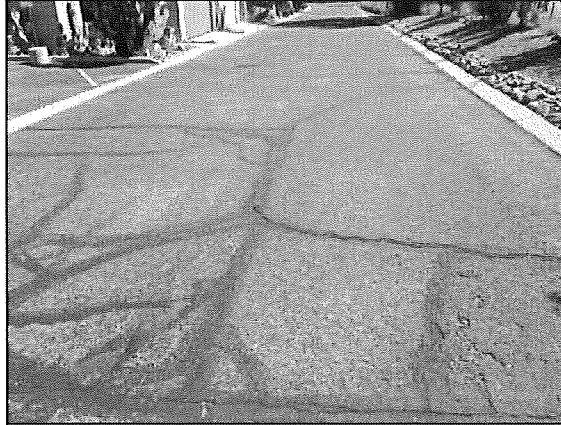
Comments: Observed to have heavy cracking throughout. Alligator cracking and failure evident in sections. Overall, the asphalt is in poor shape; however, Reserve funding is currently inadequate to be able to complete this project at this time. Life span is based on periodically seal coating and maintaining the surface.

Although your current position is Fair, our recommended increases and special assessments will be necessary to provide Reserves with sufficient funding to complete the asphalt repave project in 2023.

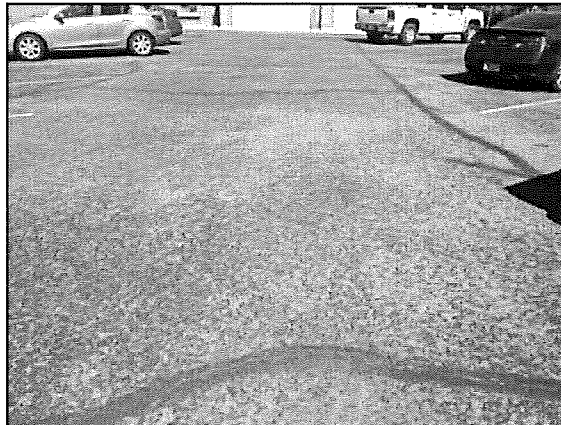
Comp #: 202 Asphalt - Seal/Repair**Quantity: Approx 70,000 Sq Ft**

Comments: We assume the asphalt will not be sealed until after complete replacement. Seal coat asphalt surfaces periodically to prevent premature cracking and deterioration.

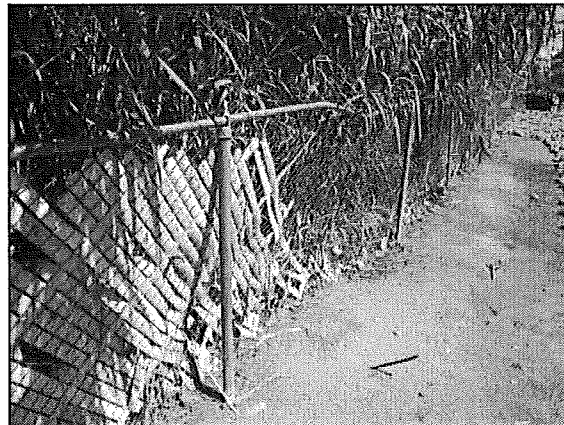
Comp #: 502 Chain Link Fence - Replace

Comments: Observed to be older and worn; however, it is a low priority at this time. Future replacement should be anticipated.

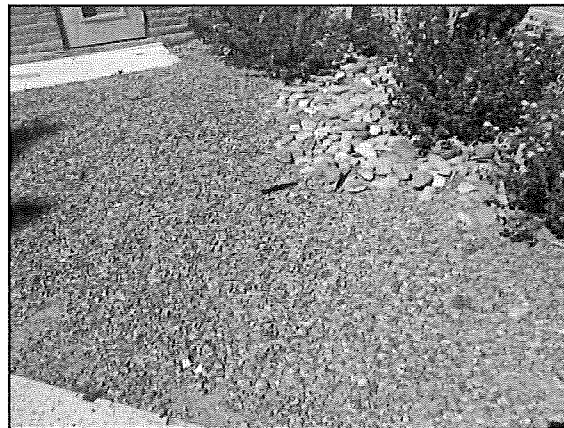
Comp #: 600 Irrigation System - Replace

Funded?: No. It is beyond the scope of this Reserve Study to quantify and assess conditions of the irrigation system. Funding can be provided for future replacement at the client's request, but we would need to be provided with cost and life expectancy estimates. Repairs and partial replacements should be included in the annual landscape maintenance budget.

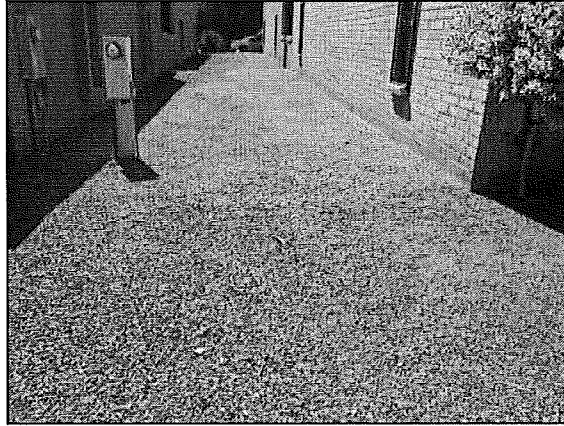
Comments: Complete replacement of the landscape granite is not anticipated. Coverage will deplete over time, so this component funds an allowance to top dress the existing granite with a new 1" layer, which is approximately 150 tons.

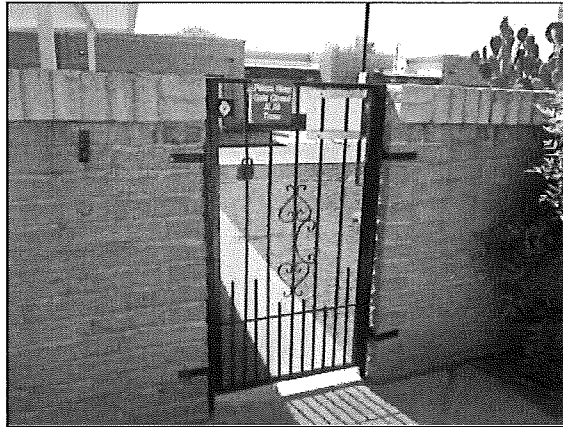
Comp #: 1100 Pedestrian Gate - Replace**Quantity: (1) Gate**

Funded?: No. Cost is below the Reserve expense threshold. Recommend replacing as needed with Operating funds.

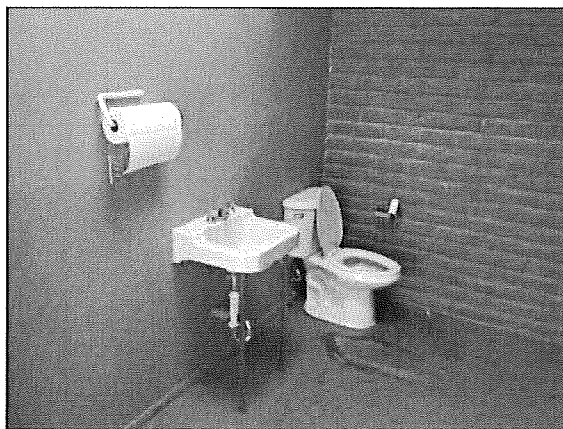
Comments: The pool area restrooms are very minimal and basic. Observed to be functional and in decent shape. This component funds to refurbish the pool area restrooms, which includes replacement of the toilets, sinks, lights, paint, etc. Repaint the restroom interiors as needed with Operating funds.
